Manhole Inspection Summary

Manhole # S41C__052MH

Inspection ☐ Is Incomplete Rating: **3) Fair**

Location Address: **246 dallas ct**

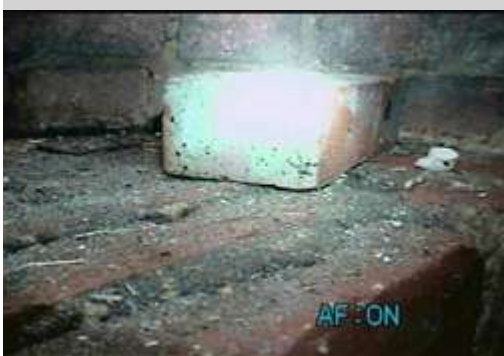
Misc

bench debris

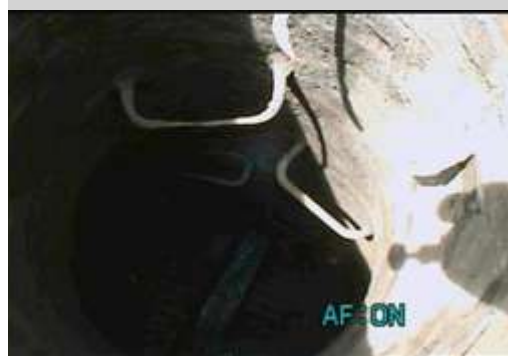
Defect 2

Count: **6** Missing: **1** ☒ **Corroded**

corroded steps

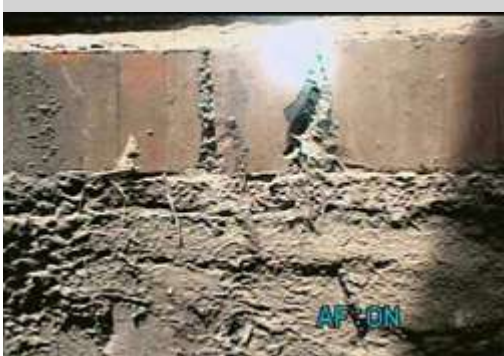
Defect 1

Condition: ☐ Sound ☒ **Cracked** ☐ Root Intrusion ☒ **Loose Brick** ☐ Deteriorated

Infiltration: ☐ None ☒ **Joint** ☐ Cracks ☐ Mortar ☐ Roots ☐ Wall

chimney loose bricks, cracked, infiltration, frame adj
